MS13-2-7 X-ray analyses on the variation of the surface and structure properties of GaN and AlN single crystals subject to femtosecond laser irradiation
#MS13-2-7

B. Shivachev¹, T. Petrov²

¹Institute of Mineralogy and Crystallography "Acad. Iv. Kostov", Bulgarian Academy of Sciences - Sofia (Bulgaria), ²Institute of Solid State Physics, Bulgarian Academy of Sciences - Sofia (Bulgaria)

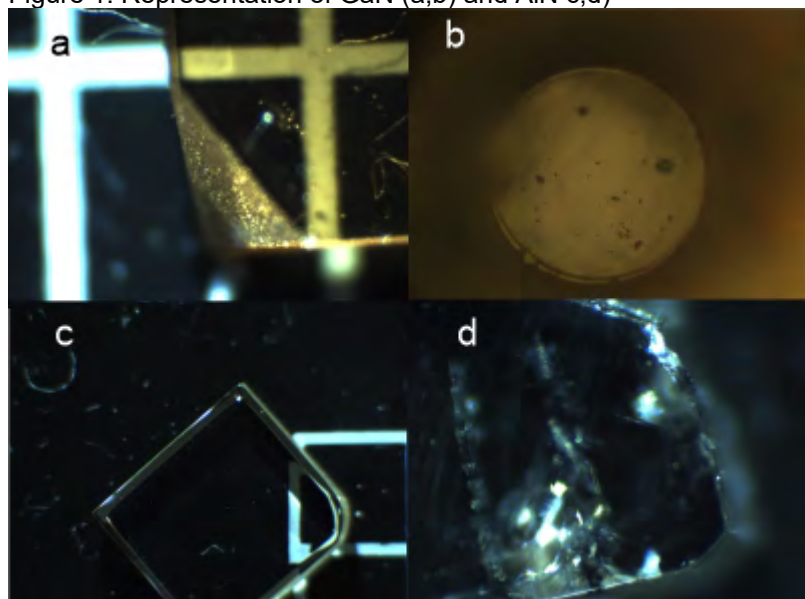
Figure 1. Representation of GaN (a,b) and AlN c,d)
