# Design and performance of a capacitor-based burn-through monitor for high-power X-ray beams at XFEL facilities

SLAC National Accelerator Laboratory, Linac Coherent Light Source, 2575 Sand Hill Road, Menlo Park, CA 94025, USA. \*Correspondence e-mail: wgl@slac.stanford.edu

The reliable and rapid detection of uncontrolled X-ray beam propagation is critical for machine and personnel protection at high-power X-ray free-electron lasers. We present the design, operation, and performance of the X-Ray Flux Capacitor (XRFC) burn-through monitor (BTM), a parallel-plate capacitor device implemented as a printed circuit board, intended to provide an inexpensive, scalable, and fail-safe beam containment monitoring solution when used with appropriate readout electronics. The capacitor BTM operates on the principle that focused high-power X-rays degrade the FR-4 dielectric between the capacitor layers, resulting in a high-voltage electrical short that is easily detectable. Ninety-two high-voltage prototype capacitor BTMs were tested at various beam parameters at the Linac Coherent Light Source XCS and XPP endstations, using X-ray energies between 7.17 keV and 13.1 keV. All capacitor BTMs shor

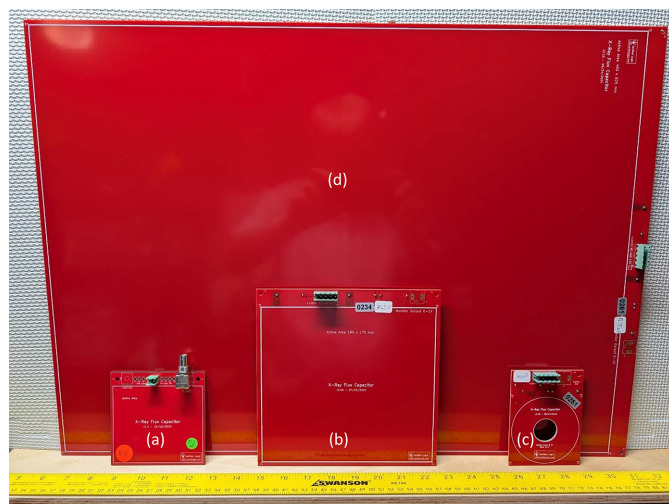
**Figure 2**

Photograph of the different prototype capacitor BTMs: (a) early prototype with sensitive area of 100 mm × 85 mm; (b) medium prototype with sensitive area 195 mm × 175 mm; (c) small prototype with 75 mm outer- and 25 mm inner diameter sensitive area; (d) large prototype with sensitive area 625 mm × 460 mm.

A total of 92 high-voltage capacitor BTM prototypes were tested in 2024, including 19 original prototypes and 73 improved prototypes of varying sizes. The PCBs were sourced from four different manufacturers [Vector Fabrication (<https://vectorfab.com/>), JLCPCB (<https://jlcpcb.com/>), PCB-Way (<https://www.pcbway.com/>), and Cirexx (<https://www.cirexx.com/>)] to investigate the dependence of performance on fabrication consistency. Four active area sizes were tested:

- (i) Original: 100 mm × 85 mm (capacitance 25–27 nF), see Fig. 2(a).
- (ii) Small, annular area: 75 mm outer and 25 mm inner diameter (capacitance 15–17 nF), see Fig. 2(c).
- (iii) Medium: 195 mm × 175 mm (capacitance 87–103 nF), see Fig. 2(b).
- (iv) Large: 625 mm × 460 mm (capacitance 750–850 nF), see Fig. 2(d).
